Products TS30, TM30, TPS1200, GPS1200, RX1250

Version SmartWorx v7.53

These Release Notes contain important information about the new SmartWorx v7.53 software that can be loaded onto all models of TS30, TM30, TPS1200, GPS1200 and RX1250 instruments.

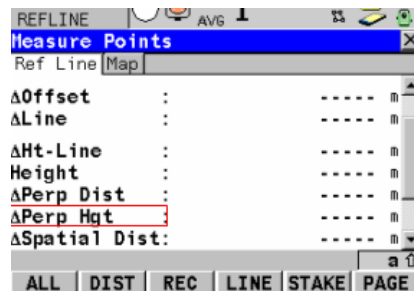
New output value in Application 'Reference Line'

The Reference Line Application on TS30, TM30, TPS1200, GPS1200, RX1250 contains the new output value 'Delta Perpendicular Height'. This value reflects the perpendicular height of a point to the line and is also supported by LGO format manager.

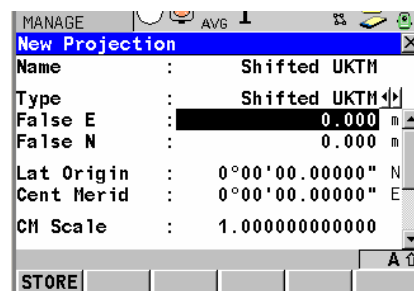
Introduction of a new projection type

The new projection type 'shifted UKTM' is added to support local site variations of specific coordinate systems.
